Industry – Paper production

Location	Ngodwana, South Africa
Client	Confidential
Year	2020
Application	Water Treatment
Contaminants	Silica
Solution	Hydramix

Synopsis

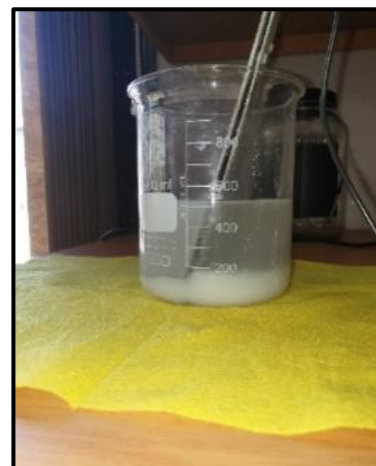
Figure 2: Precipitation formation during treatment.

The Hydramix electro-coagulation system was used to treat the effluent. Figure 2 shows the raw sample before treatment, the precipitation that occurs during the treatment and then a comparison of the raw and post treated samples. Samples were treated at different electrical dosing.

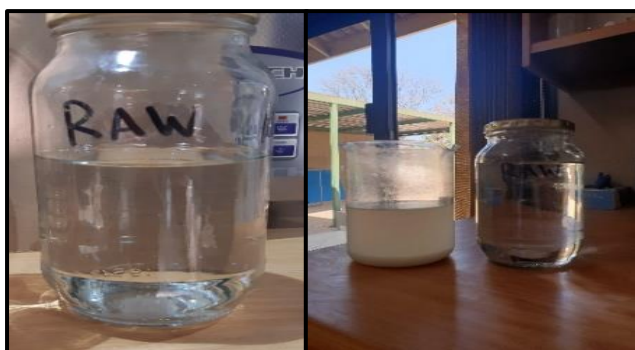
Figure 1: Raw sample, during treatment, post treatment comparison.
